## **Limited Visual Dam Safety Inspection Summary Report**

**MA-126**

**Kahana Dam**

**May 2006**

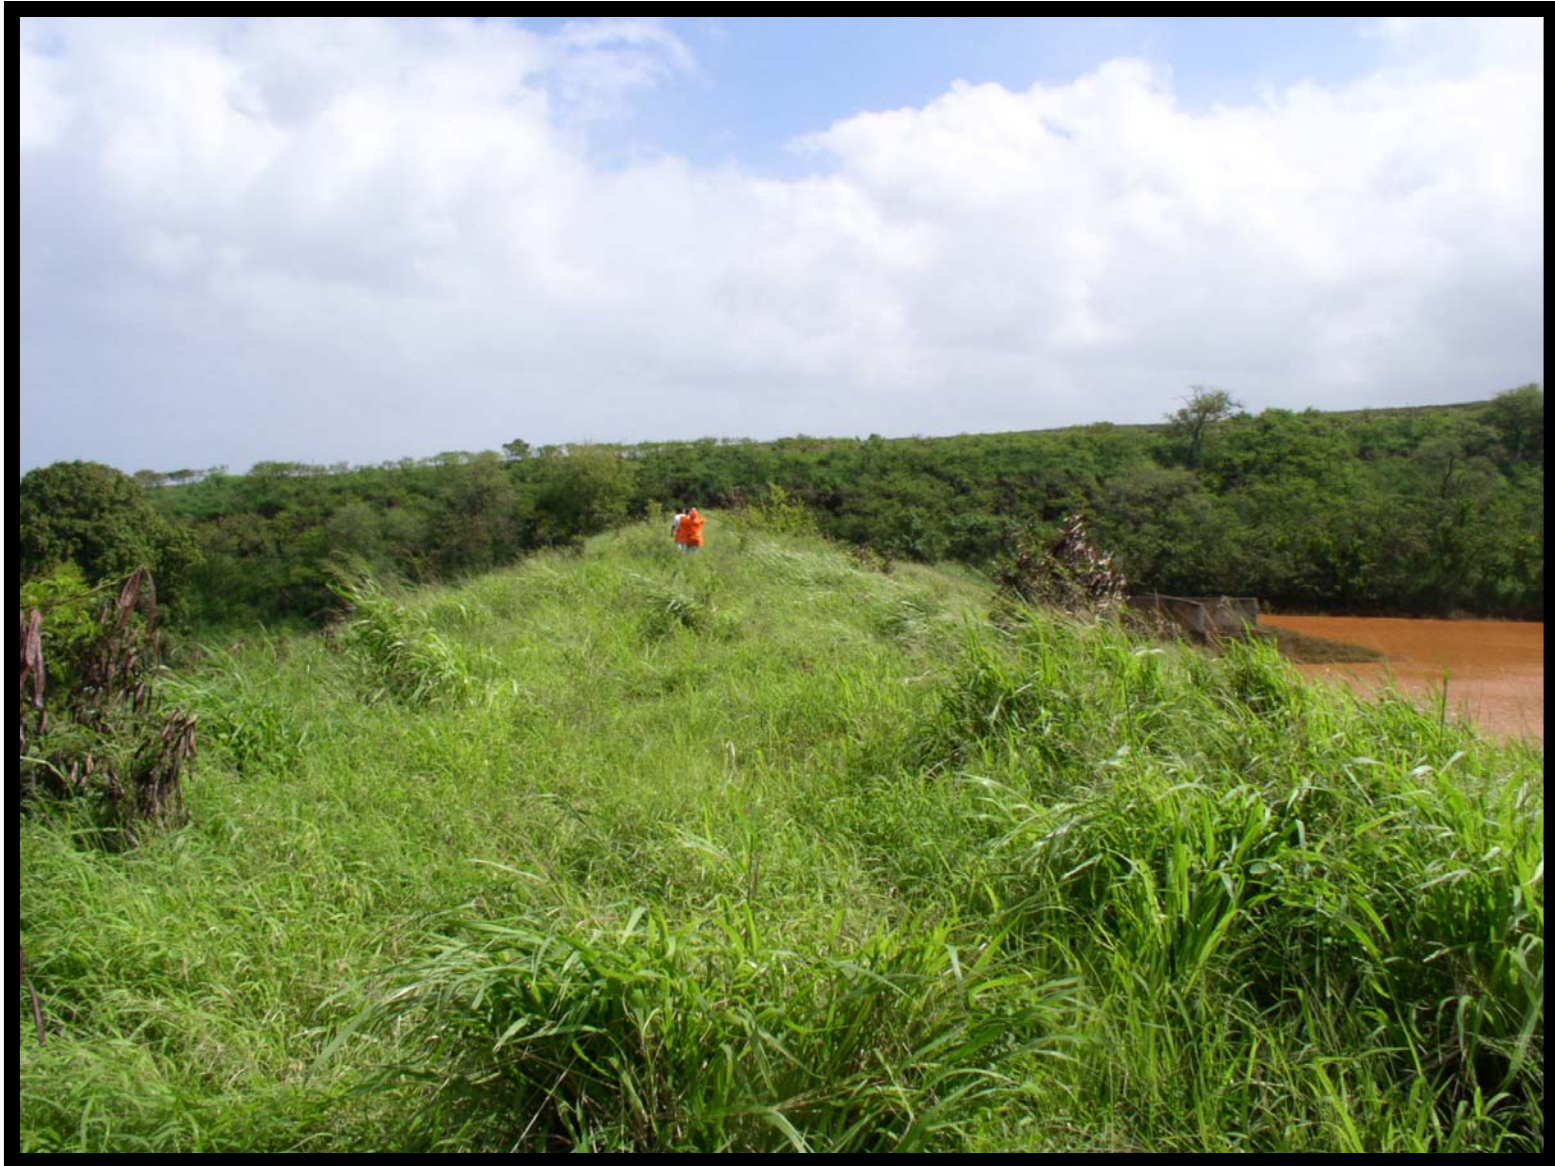
This crest of the dam is approximately 15 feet wide, accessible by walking. At the time of this inspection, the crest was covered by tall grass. Per Michael Hayama of Hawaii DLNR, transverse and axial cracks formed in the crest of this dam near the abutment several years after it was constructed. The cracks were attributed to differential settlement between the crest and the abutment. The cracks were repaired by filling with sand. They have not recurred since they were repaired.

- a. The dam crest appeared to be in fair to poor condition and requires corrective action.
- b. Portions of the crest were not visible due to high grass. Clear high vegetation and maintain low to enable easy visual inspection.

126 Crest - Looking along the crest of Kanaha Dam. Note the tall grass.

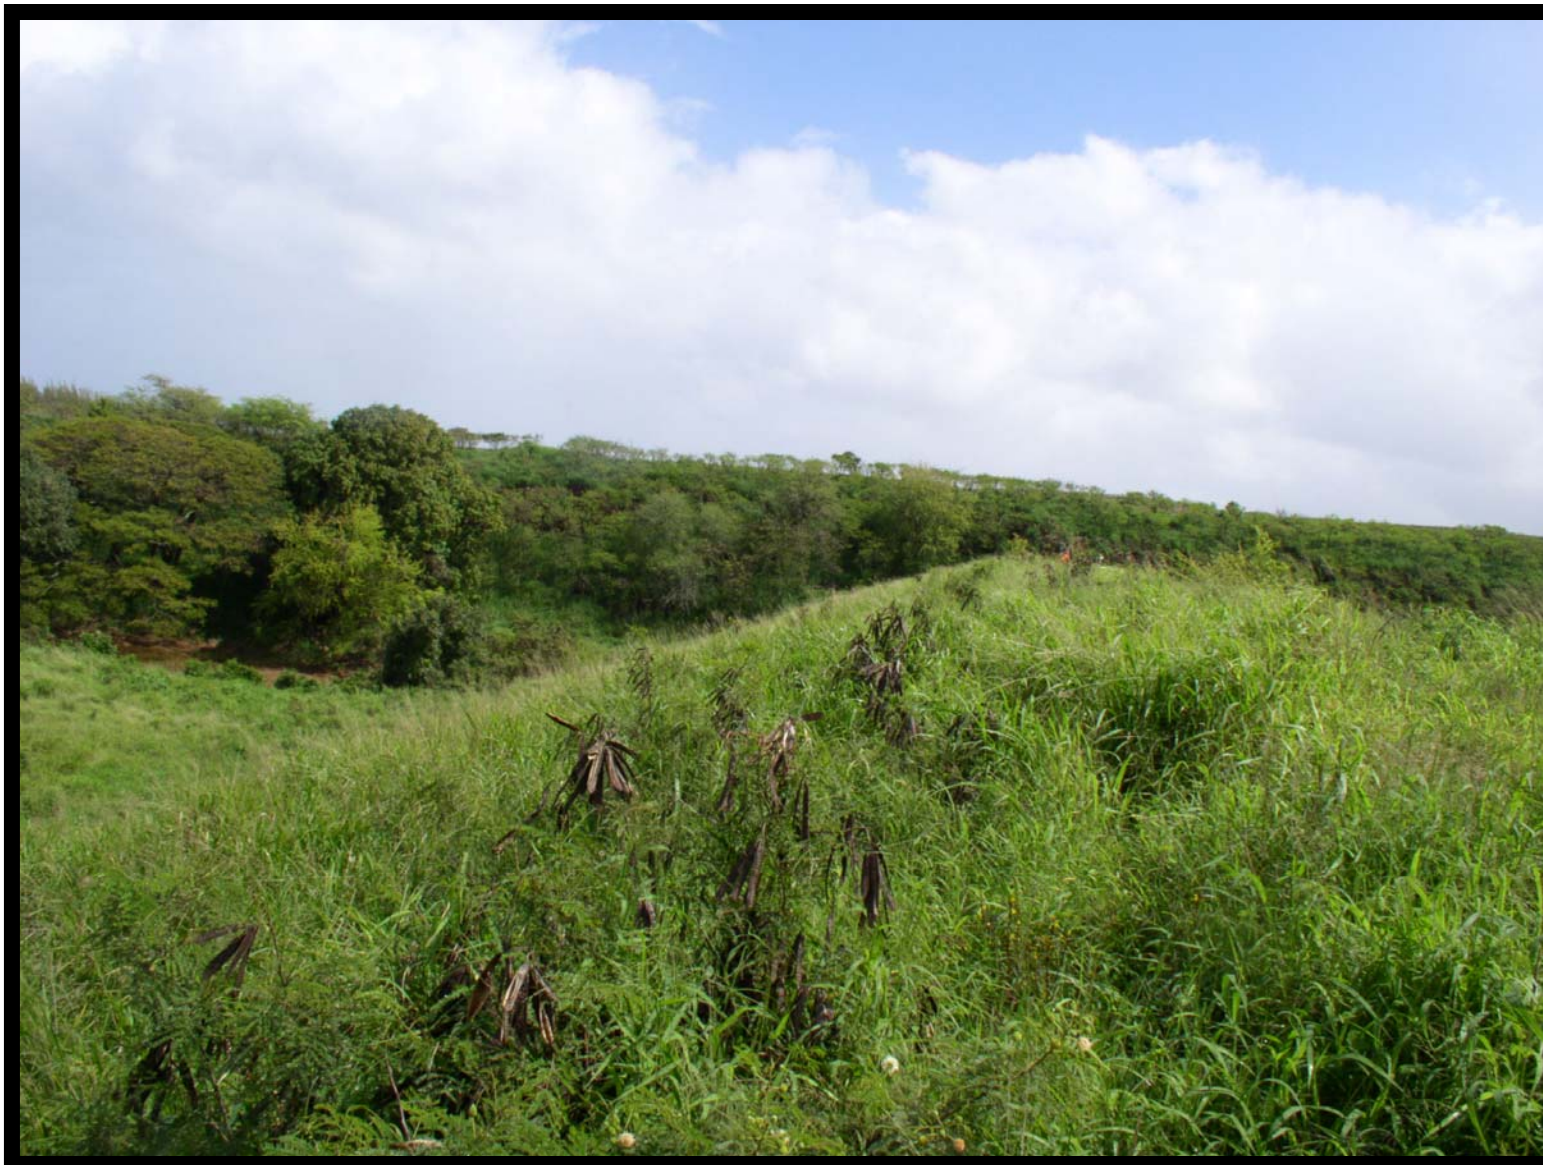
- a. The downstream slope appeared to be in fair to poor condition and requires corrective action.
- b. Slope protection needs maintenance. The tall vegetation needs to be mowed.

- c. The downstream slope was not visible due to high grass. Clear high vegetation and maintain low to enable easy visual inspection.
- d. Trees were observed on the downstream slope. Trees have been identified as the probable cause of piping failures and can possibly cause severe damage to the embankment if they are uprooted during high winds. Corrective action is required to remove the tree hazards from the dam. Acceptable remedies include removal of the tree and its root structure down to a 2-inch diameter and reconstructing the damaged embankment section. All repair work shall be accomplished as per the requirements of a licensed geotechnical or structural engineer. Routinely monitor the damaged area for signs of settlement and seepage.

126 View of the downstream slope of Kanaha Dam. Note the tall grass.

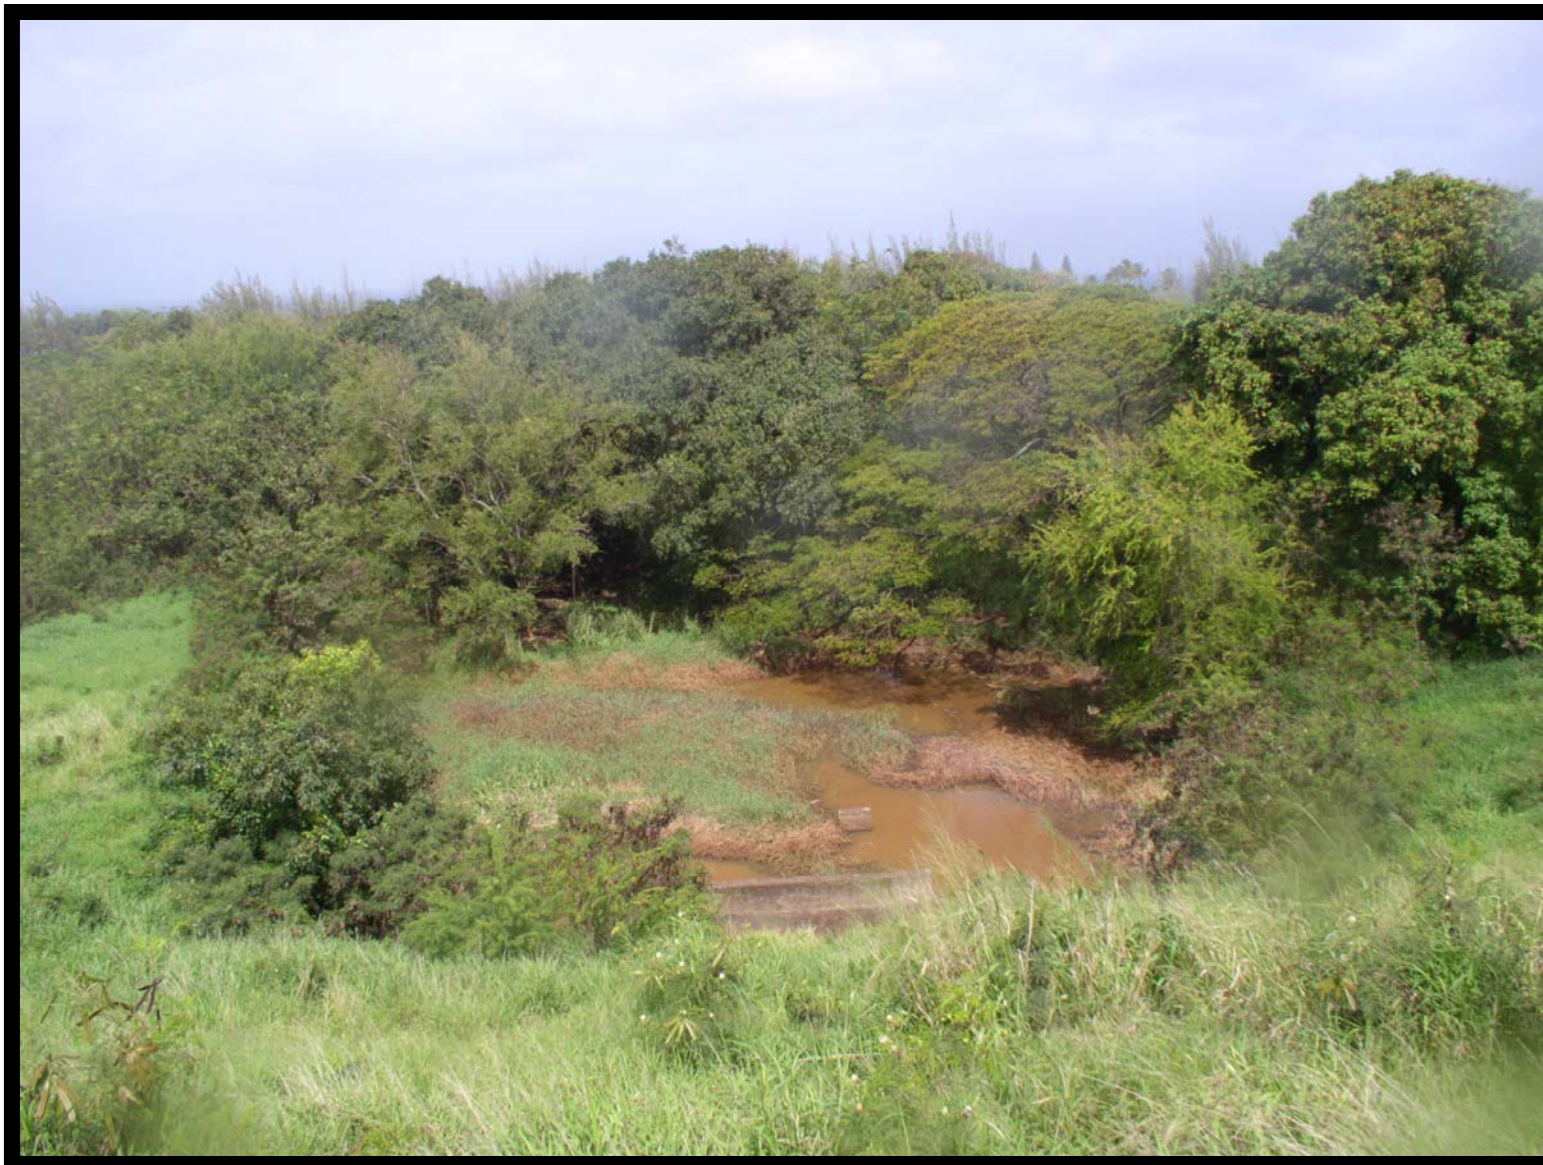
- a. The outlet works were not inspected. (Due to vegetation)
- b. The outlet works were not tested.
- c. The outlet works appeared to be in fair to poor condition and requires corrective action.
- d. Were not visible due to high grass and bush vegetation. Clear high vegetation and maintain low to enable easy visual inspection.
- e. The debris should be removed from the energy dissipaters to restore their full function.

126 View from the crest of Kanaha dam looking downstream  
at the outlet channel

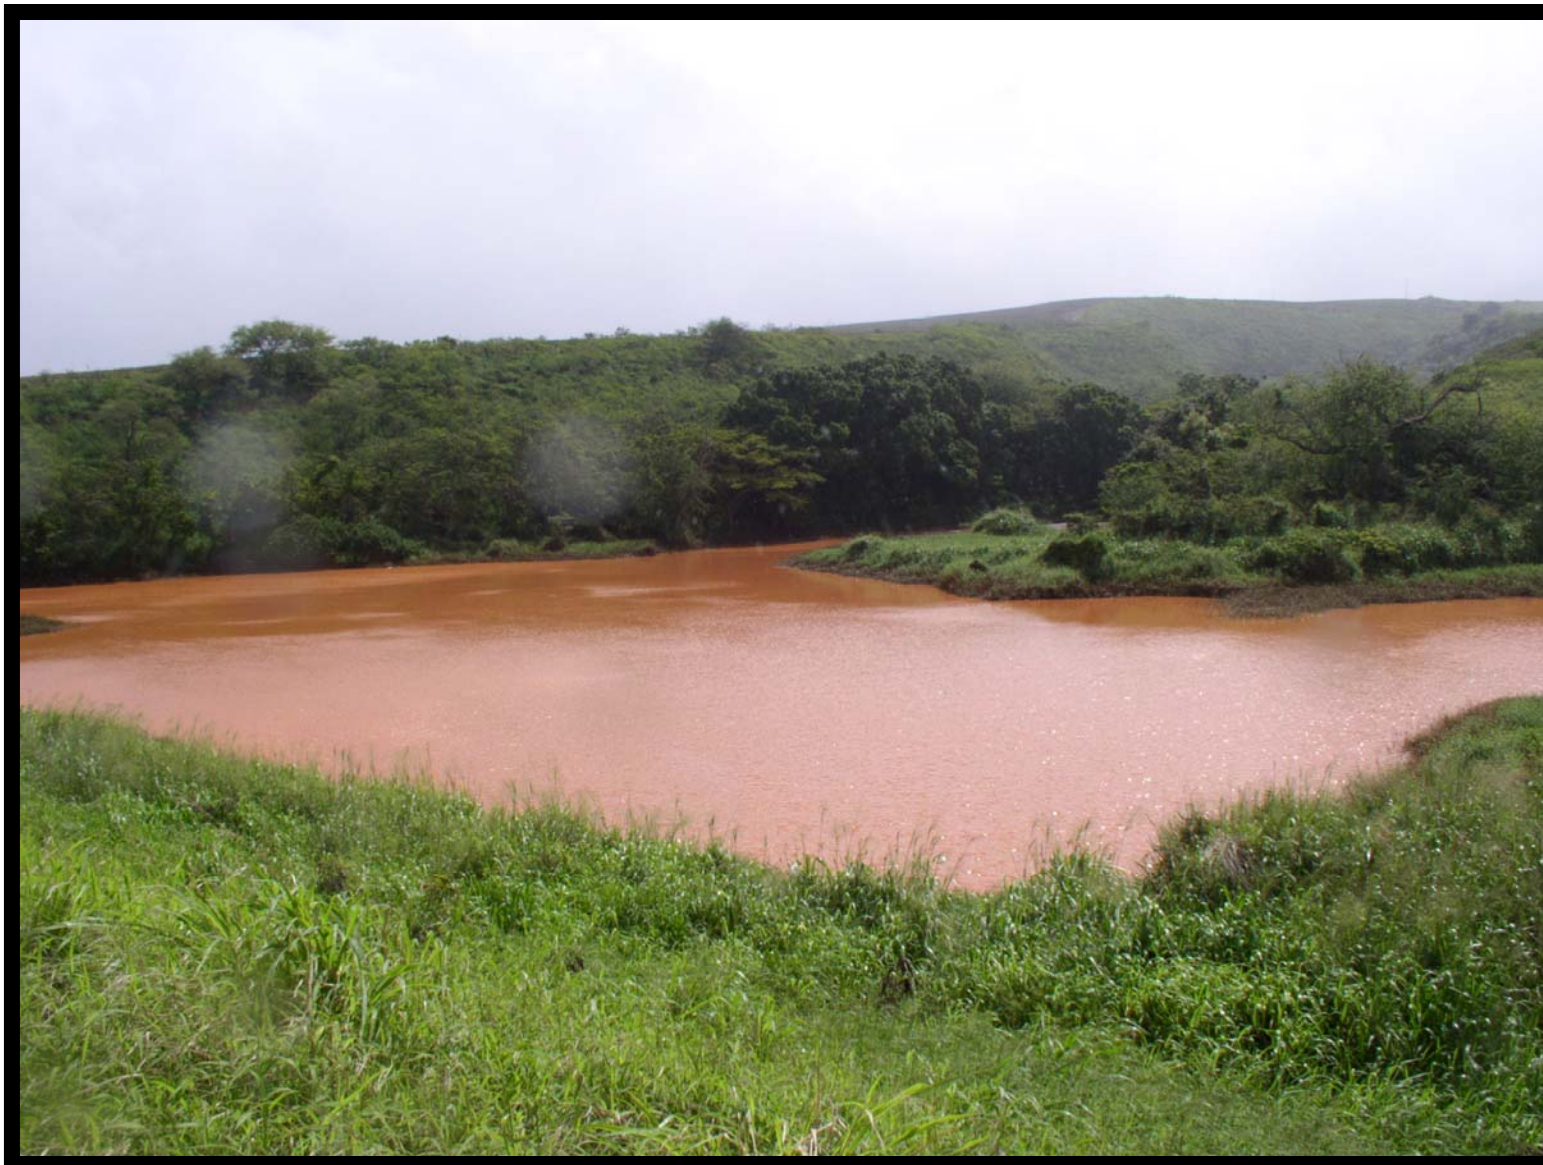
The water level in the reservoir was estimated as about 8 feet deep at the time of inspection, which is the normal level. The owner said the outlet valve is broken and left in an open position at all times. There was no staff gage in the reservoir.

- a. The reservoir appeared to be in fair to poor condition and requires corrective action.
- b. A staff gage was not observed in the reservoir. Provide some method of quantifying the water level within the reservoir.

126 View of Kanaha Dam reservoir looking from the crest

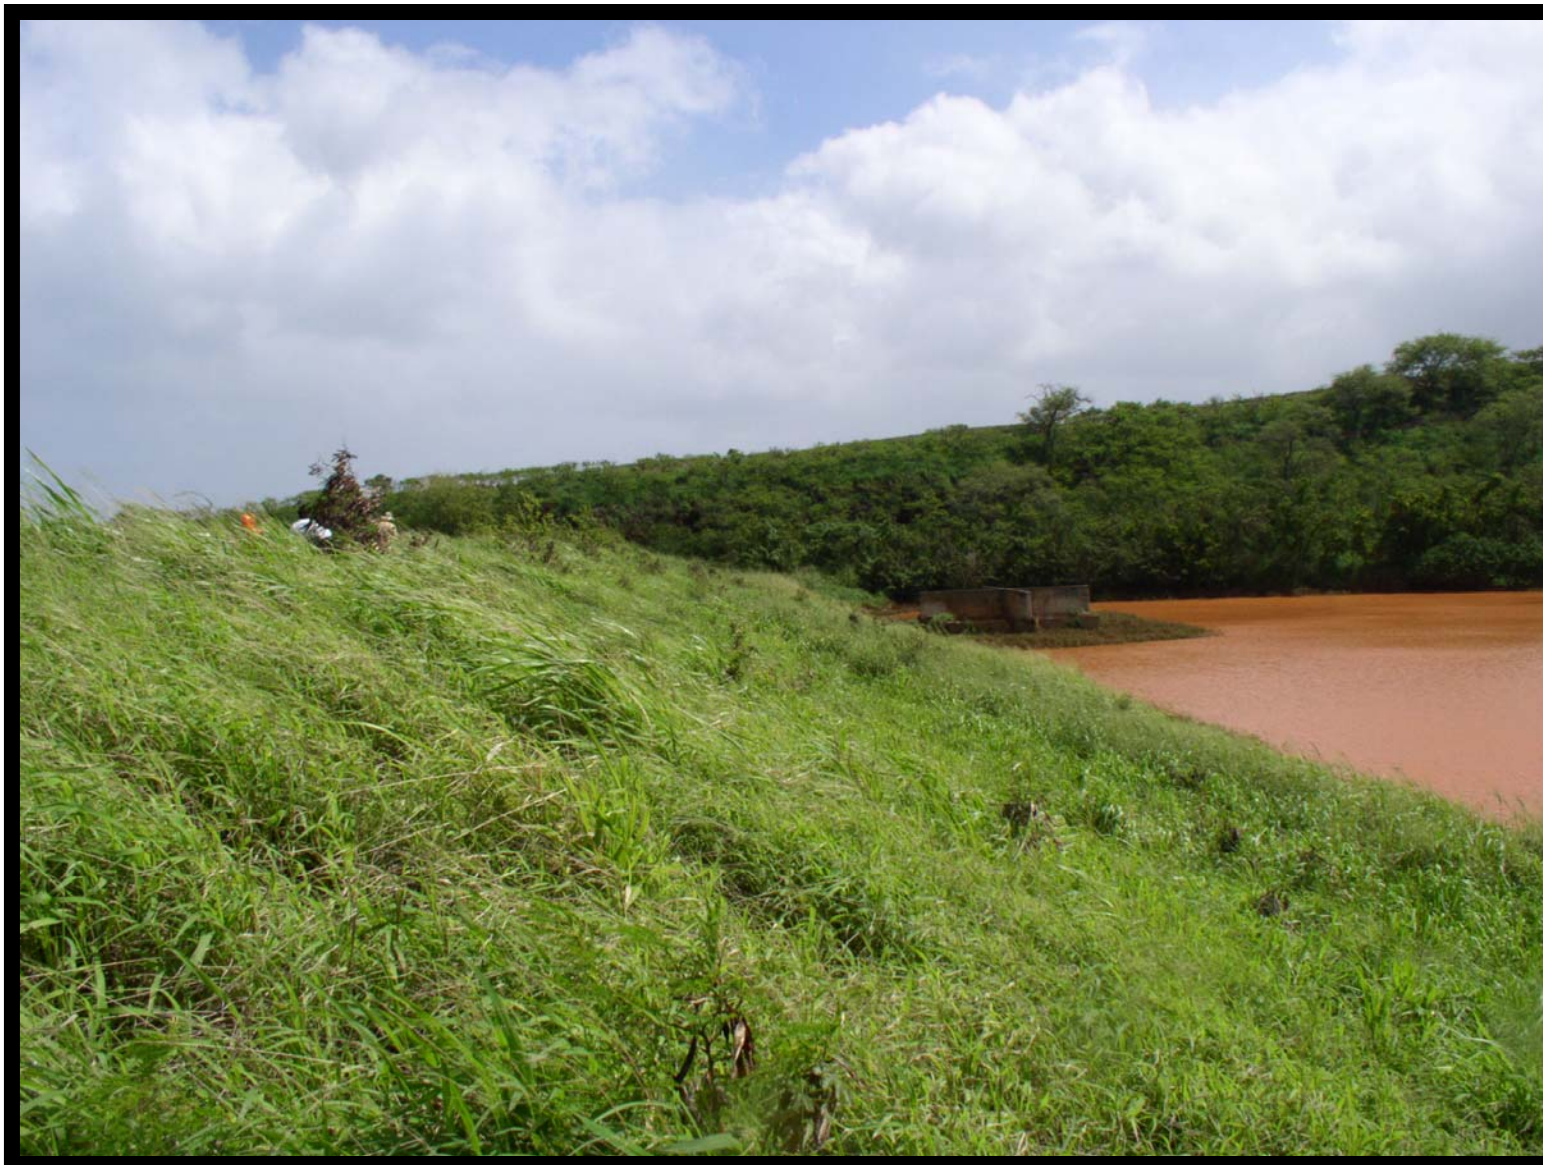
- a. The upstream slope appeared to be in fair to poor condition and requires corrective action.
- b. Slope protection needs maintenance. The tall grass needs to be mowed and maintained on a regular basis.
- c. The upstream slope was not visible due to high grass. Clear high vegetation and maintain low to enable easy visual inspection.

126 View of upstream slope of Kahana Dam. Note the tall grass.
